Accessibility Self-Evaluation and Transition Plan

SAN FRANCISCO MARITIME

NATIONAL HISTORICAL PARK | CA

JANUARY 2016

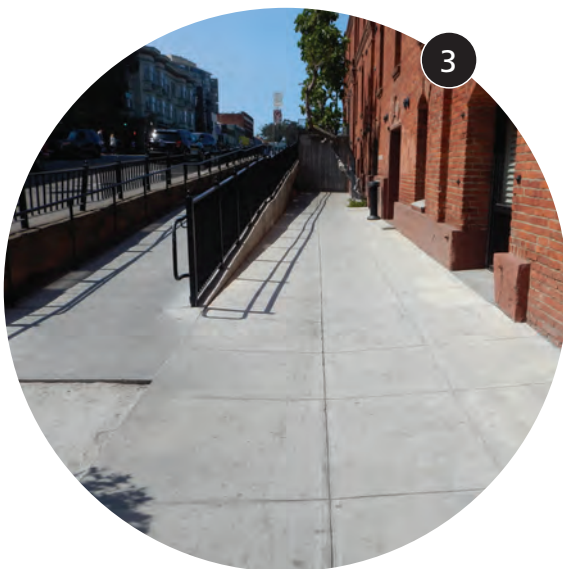
Site Features 2

- 3 **Accessible Route and Walking Surfaces.** Coordinate with the City of San Francisco to implement the following solutions. 1) Provide an accessible route with maximum 2% cross slopes on Beach Street. 2) Develop a standard operating procedure that states how people can access the building via an accessible route and that Beach Street does not currently meet ABAAS standards. 3) Post the standard operating procedure of access to the Argonaut via Beach Street to the park website, as well as a wayfinding sign indicating the accessible route to the Argonaut. Note: Reference the City of San Francisco ADA Transition Plan for Curb Ramps and Sidewalks found at: <http://www.sfgov2.org/modules/showdocument.aspx?documentid=2050>

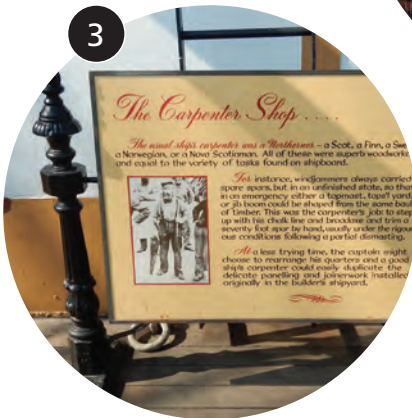
Site Features 2

2 Main deck to poop deck

2 Main deck to tween deck

around ship that explains conditions and settings within and around the ship. 6) Forecastle and small rooms throughout the ship can be made accessible through a live video feed with simultaneous audio tour and tactile map to be a part of guided tours that are not accessible.

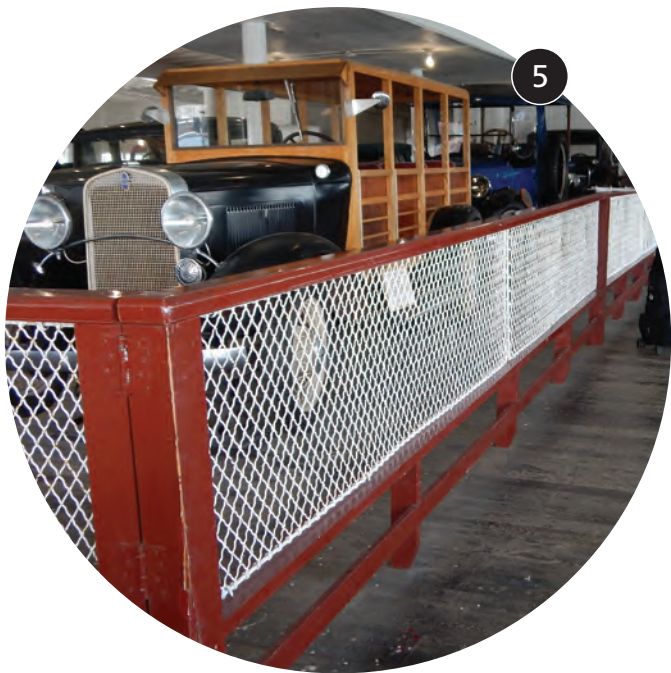
Site Features 2

HURRICANE DECK

PASSENGER DECK

MAIN DECK REPAIRS

- 4 **Cell Phone Tour (Hyde Street Pier).** 1) Provide audio description on cell phone tour and large-print transcript that describes the “Eureka.”
